27 Leon St, Tingalpa QLD 4173

Pre-Purchase Standard Property & Timber Pest Report

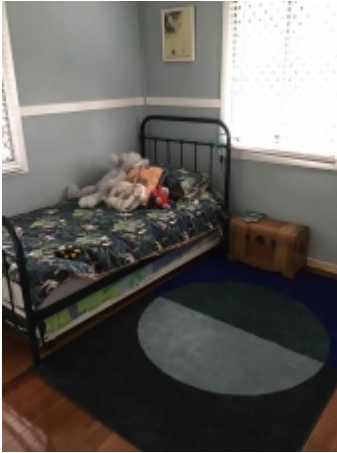
Showing examples of obstructions (e.g. wall, floor, ceiling coverings, cabinets, window furnishings, vegetation, insulation and ducted AC, furniture and stored goods, etc.)

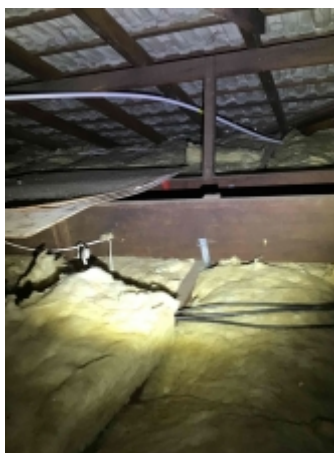
Parts of the roof space due to accessibility

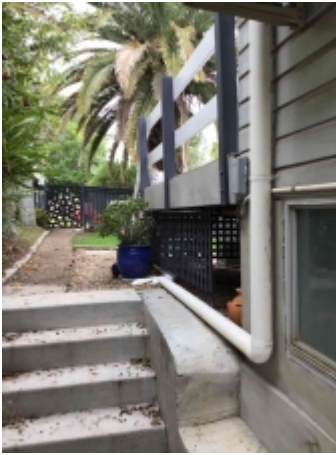
Showing example of insufficient balustrading

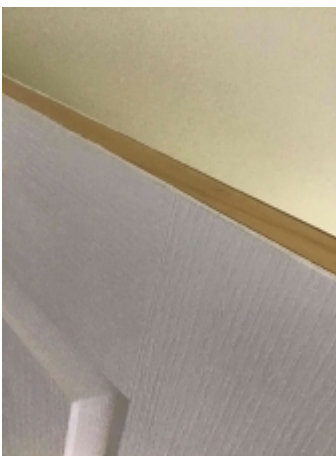
Doors need to be sealed on all four edges to ensure that no moisture can penetrate to the door as per manufacture specifications specially external and wet area doors, recommend engaging a painter to rectify and avoid further deterioration.

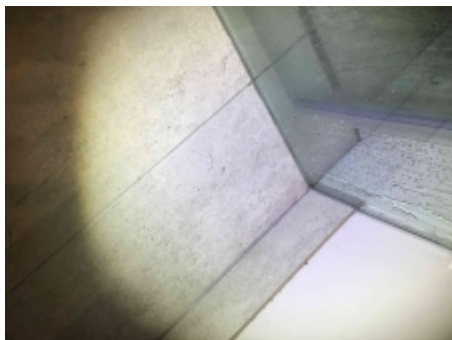
Water leaks through the shower screens. Recommend engaging a waterproofing technician or plumber to re-seal the joints to reduce the risk of water leaks and penetration, Lower level bathroom

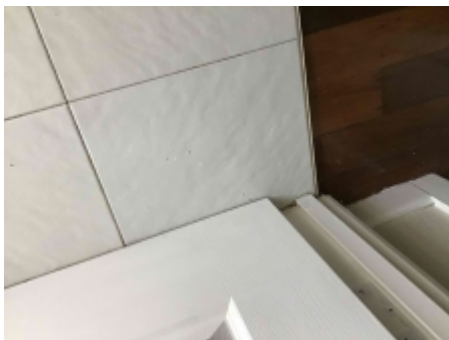
Cracked/loose/missing sealant/grout to parts of bathroom. Recommend resealing to reduce the risk of water leaks and damage

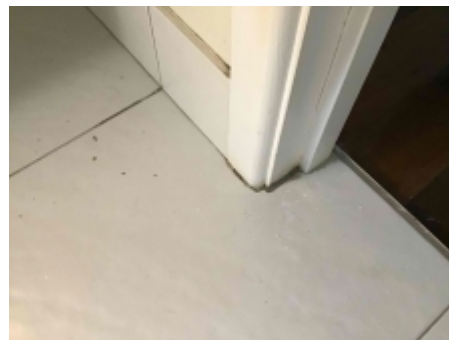
Cracked/loose/missing sealant/grout to parts of bathroom. Recommend resealing to reduce the risk of water leaks and damage

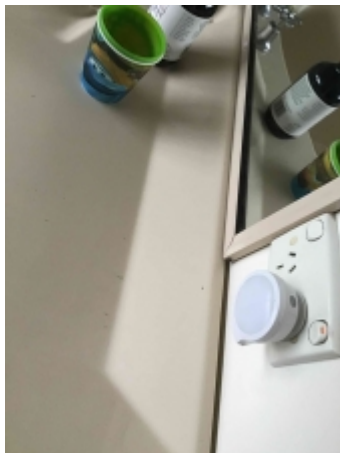
Cracked/loose/missing sealant/grout to parts of bathroom. Recommend resealing to reduce the risk of water leaks and damage

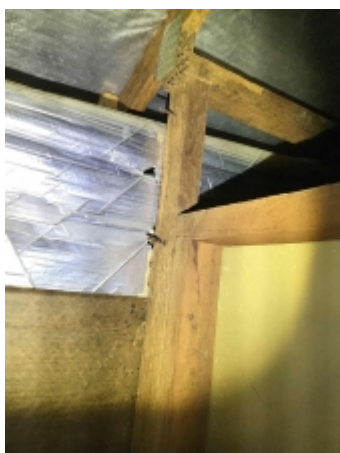
Termite damage to parts of the roof framing. Recommend engaging a builder for further invasive inspection to the area to determine if there is any concealed damage and replace all damaged timbers., Lower level roof space

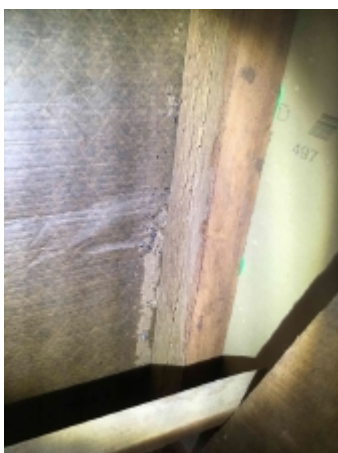
Termite damage to parts of the roof framing. Recommend engaging a builder for further invasive inspection to the area to determine if there is any concealed damage and replace all damaged timbers., Lower level roof space

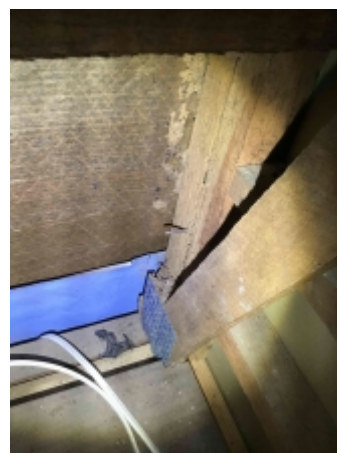
Termite damage to parts of the roof framing. Recommend engaging a builder for further invasive inspection to the area to determine if there is any concealed damage and replace all damaged timbers., Lower level roof space

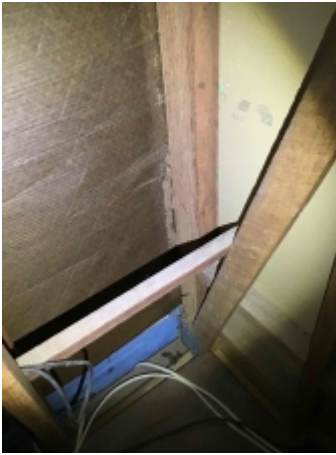
Termite damage to parts of the roof framing. Recommend engaging a builder for further invasive inspection to the area to determine if there is any concealed damage and replace all damaged timbers., Lower level roof space

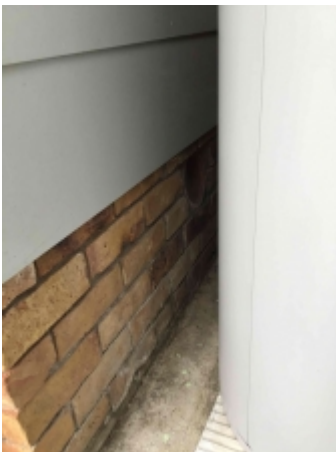
Missing ant caps to parts of the walls, recommend a builder to install ant caps to reduce the risk of termite attacks from the concealed areas

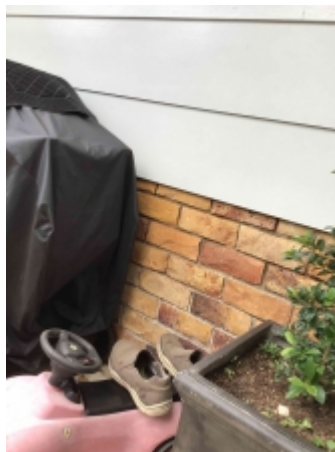
Missing ant caps to parts of the walls, recommend a builder to install ant caps to reduce the risk of termite attacks from the concealed areas

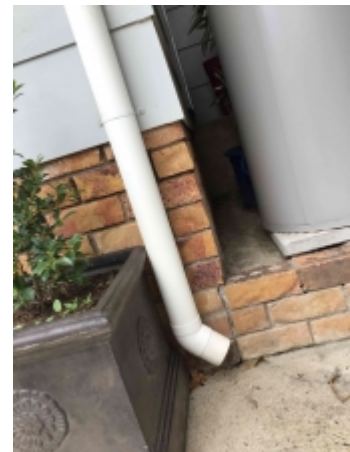
Missing ant caps to parts of the walls, recommend a builder to install ant caps to reduce the risk of termite attacks from the concealed areas

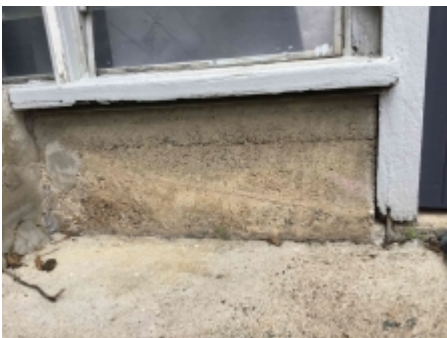
Missing ant caps to parts of the walls, recommend a builder to install ant caps to reduce the risk of termite attacks from the concealed areas

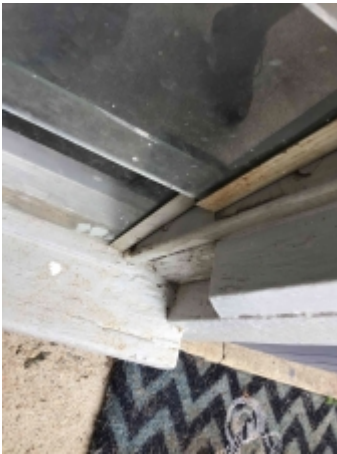
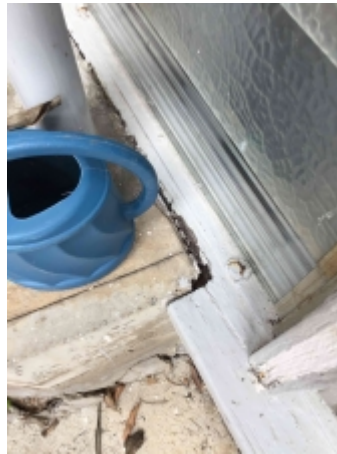
Weathered/damaged timbers to parts of the windows. Recommend engaging a builder to repair/replacing to prevent further deterioration. Make sure all exposed timbers are painted to maximise the life of the timbers

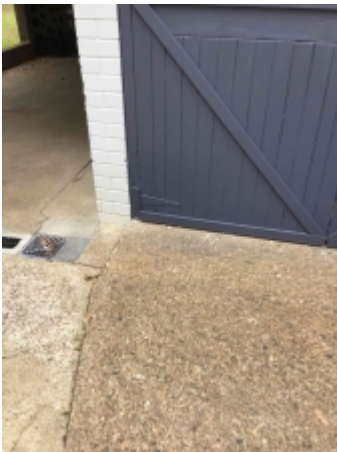
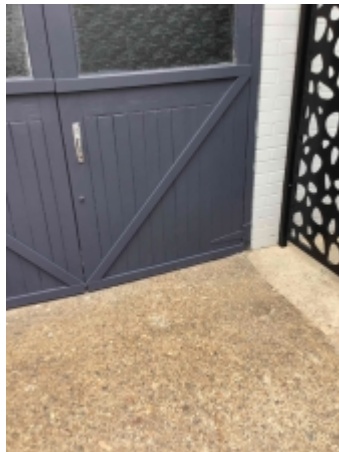
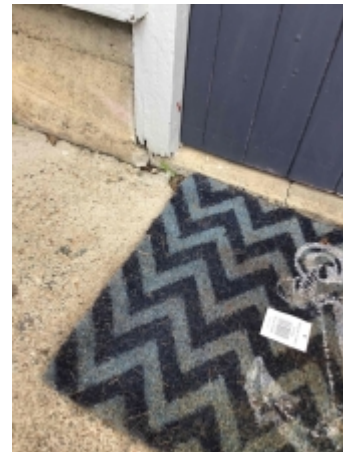
A few timbers in ground contact, recommend exposing 75mm under the timbers to reduce the risk of wood rot and termite attacks

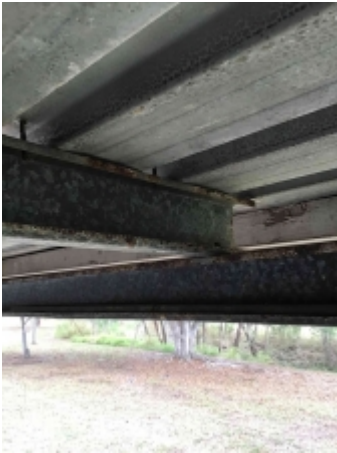
Rusting to parts of carport framing, recommend a builder to repair or replace and avoid further deterioration

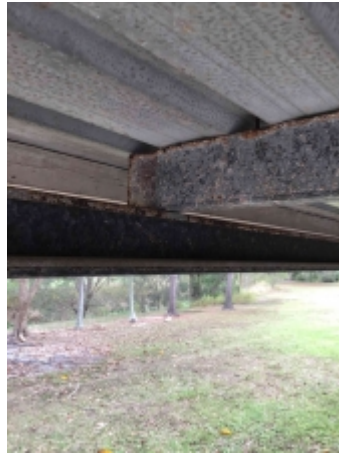
Rusting to parts of carport framing, recommend a builder to repair or replace and avoid further deterioration

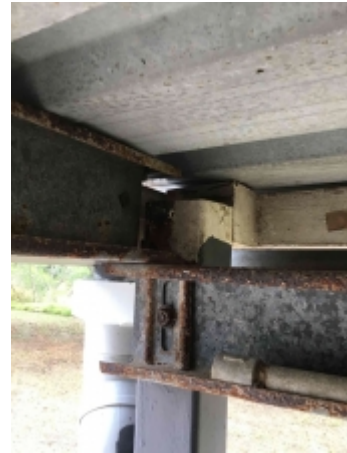
Rusting to parts of carport framing, recommend a builder to repair or replace and avoid further deterioration

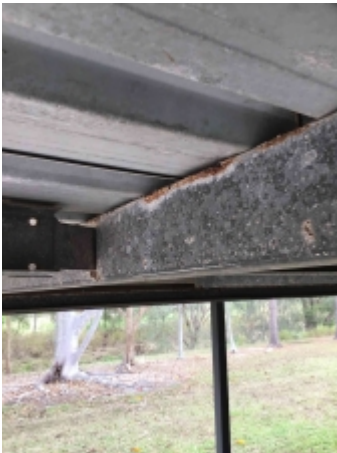
Rusting to parts of carport framing, recommend a builder to repair or replace and avoid further deterioration

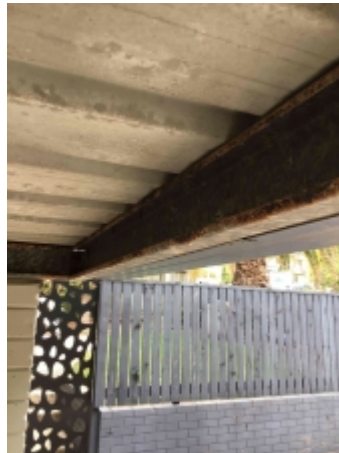
Rusting to parts of carport framing, recommend a builder to repair or replace and avoid further deterioration

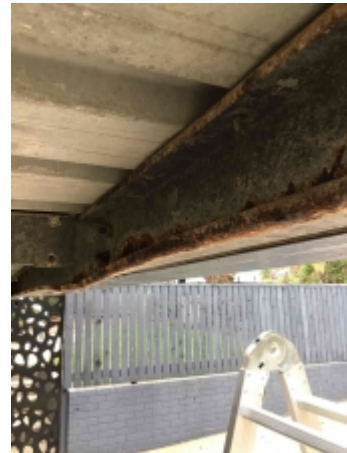
Rusting to parts of carport framing, recommend a builder to repair or replace and avoid further deterioration

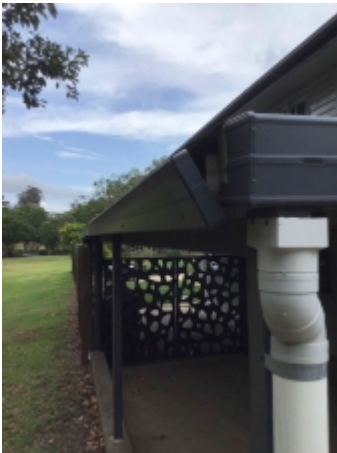
Loose flashing to the carport roof, recommend a plumber to repair or replace and avoid further deterioration

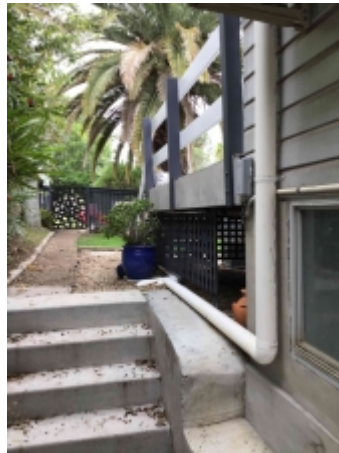
Insufficient balustrading to the external areas, balustrading should be minimum 1000 high for the patios/balconies and 865 mm for the stairs with gaps no greater than 125mm, rectify to reduce the risk of personal injury

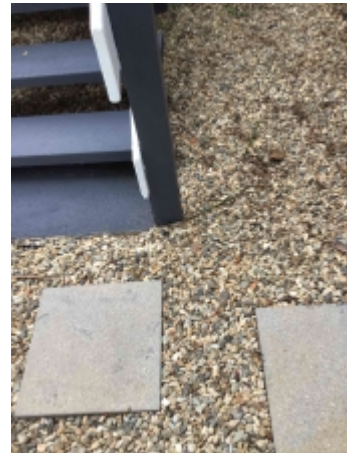
A few timbers are in contact with the ground. Recommend exposing a minimum of 75mm under all timbers to reduce the risk of termite attack and wood rot

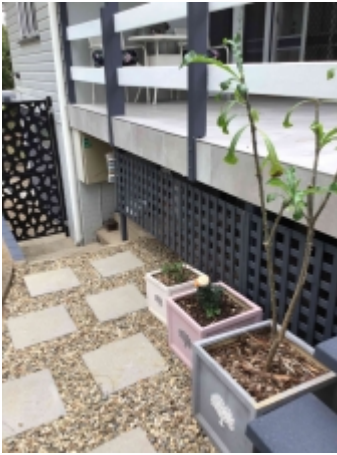
The balcony tiles require a drip edge flashing. Recommend a tiler to rectify to reduce the risk of water penetration to the building.

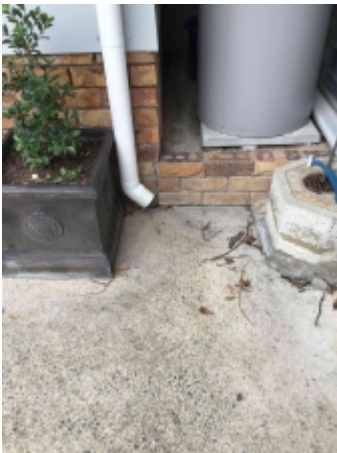
Downpipes not connected to storm water system. Recommend engaging a plumber to repair to avoid the risk of footing movement and other moisture related issues

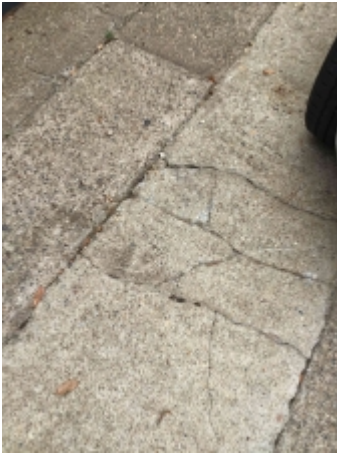
Settlement cracks to parts of the pathway/driveway. Recommend engaging a concreting contractor to repair/replace and avoid further deterioration

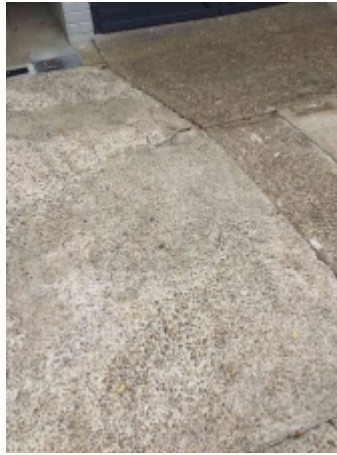
Settlement cracks to parts of the pathway/driveway. Recommend engaging a concreting contractor to repair/replace and avoid further deterioration

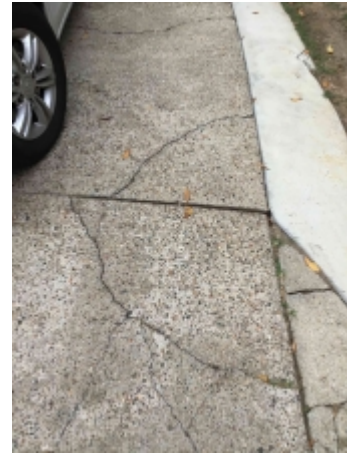
Settlement cracks to parts of the pathway/driveway. Recommend engaging a concreting contractor to repair/replace and avoid further deterioration

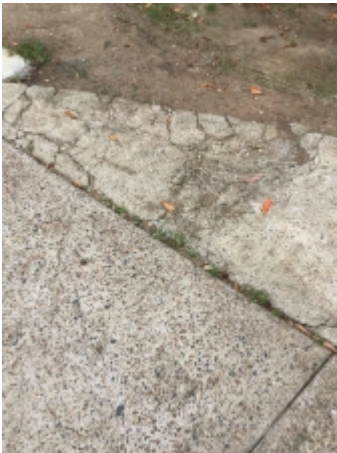
Settlement cracks to parts of the pathway/driveway. Recommend engaging a concreting contractor to repair/replace and avoid further deterioration

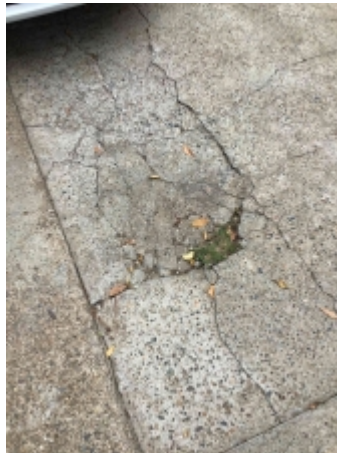
Settlement cracks to parts of the pathway/driveway. Recommend engaging a concreting contractor to repair/replace and avoid further deterioration

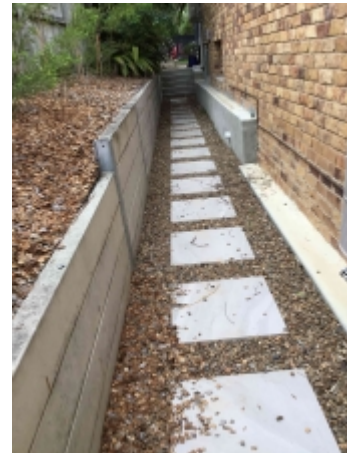
Poor surface drainage – needs improvement to reduce the risk of footing movement and other moisture related issues

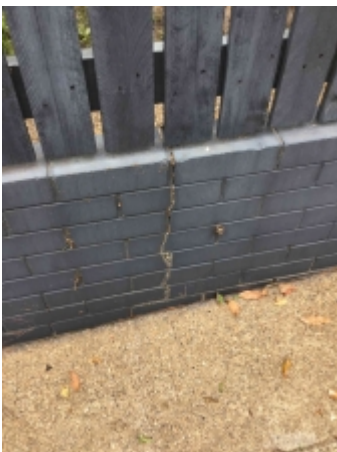
Cracked retaining wall to the front elevation, recommend a builder to repair or replace and avoid further deterioration

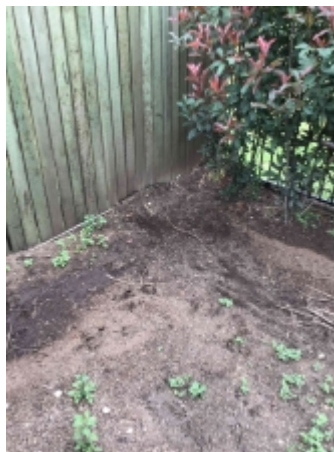
Parts of the fences are in ground contact. Recommend exposing 75mm under the timbers to reduce the risk of wood rot and termite attacks

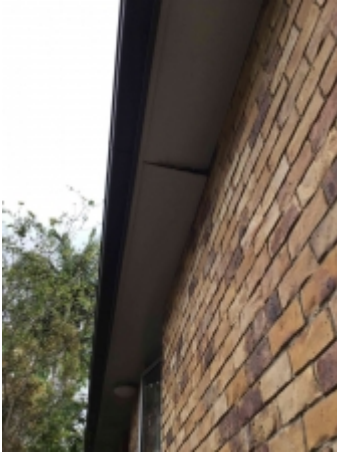
Showing loose soffit sheets

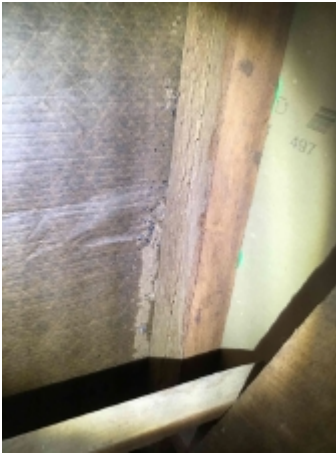
Showing example of termite damage

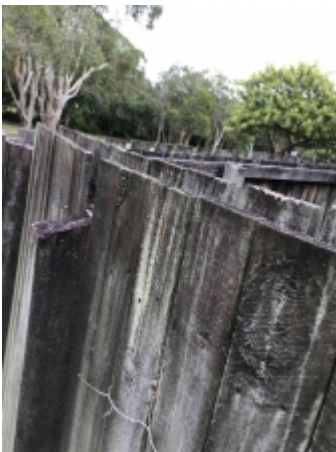
Showing example of wood rot

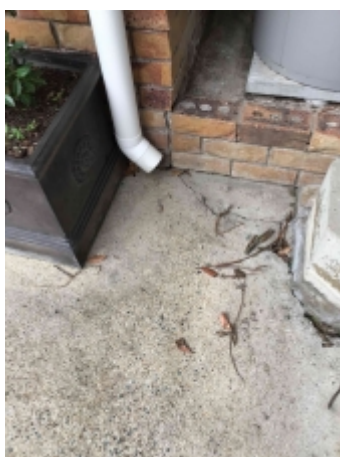
Showing example of downpipes

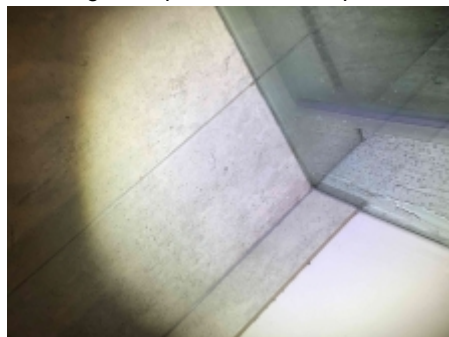
Showing example of areas with leaks

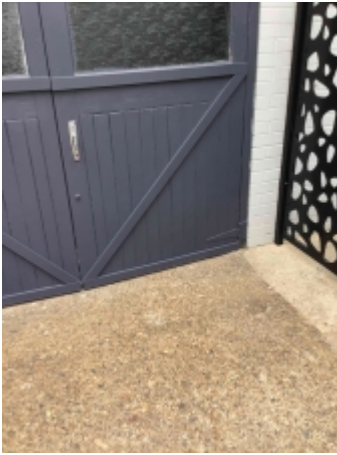
Showing example of bridging

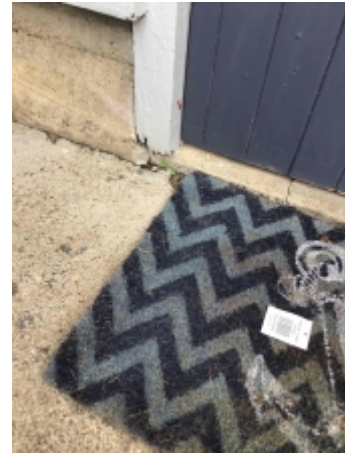
Showing example of bridging

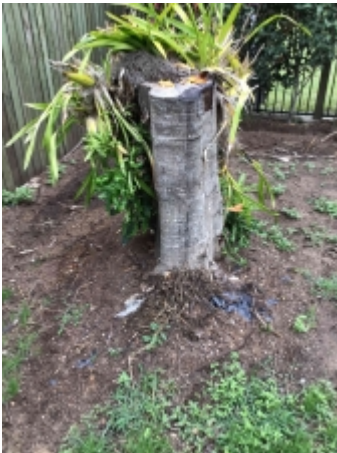
Showing example of stumps
